# City of Lloydminster Water Treatment Assessment

## Final Report

February 2025

**Reference: City of Lloydminster – Water Treatment Assessment Final Report**

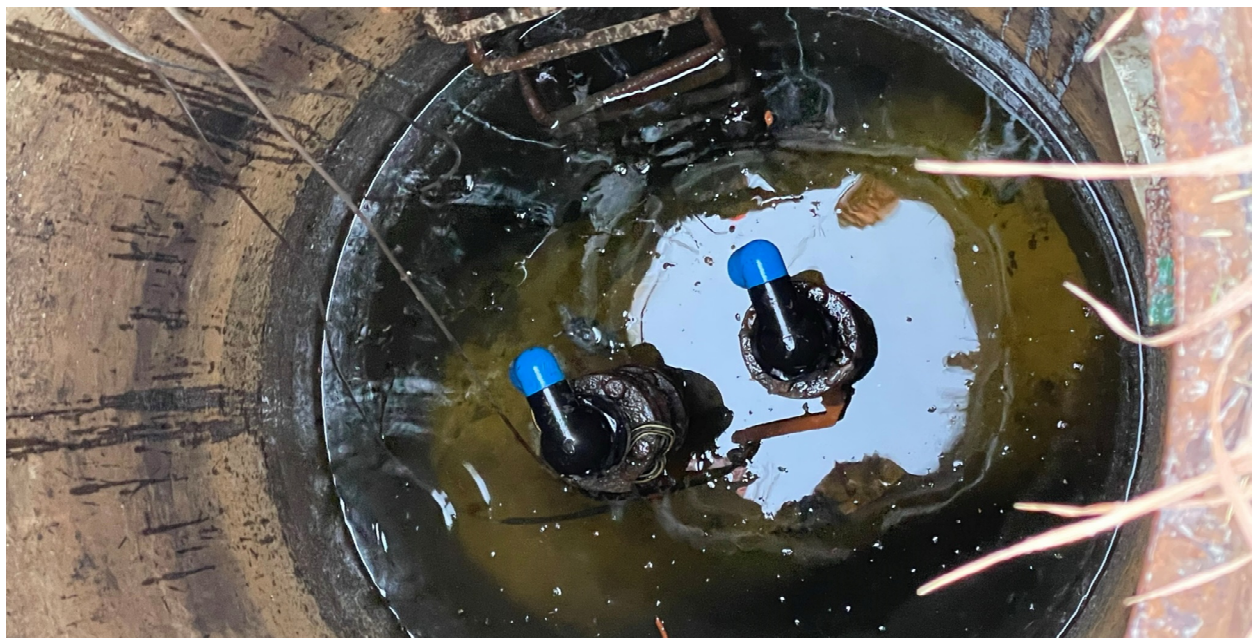
Figure 4.2 Flooded Raw Water Pipeline Vault

13. Multiple concrete vaults containing isolation and air release valves exist along the raw water line. A number of these vaults are either flooded or need of concrete repair / refurbishment. In discussions with the City a phased refurbishment program of the vaults should be completed over the next fifteen (15) years. (High)

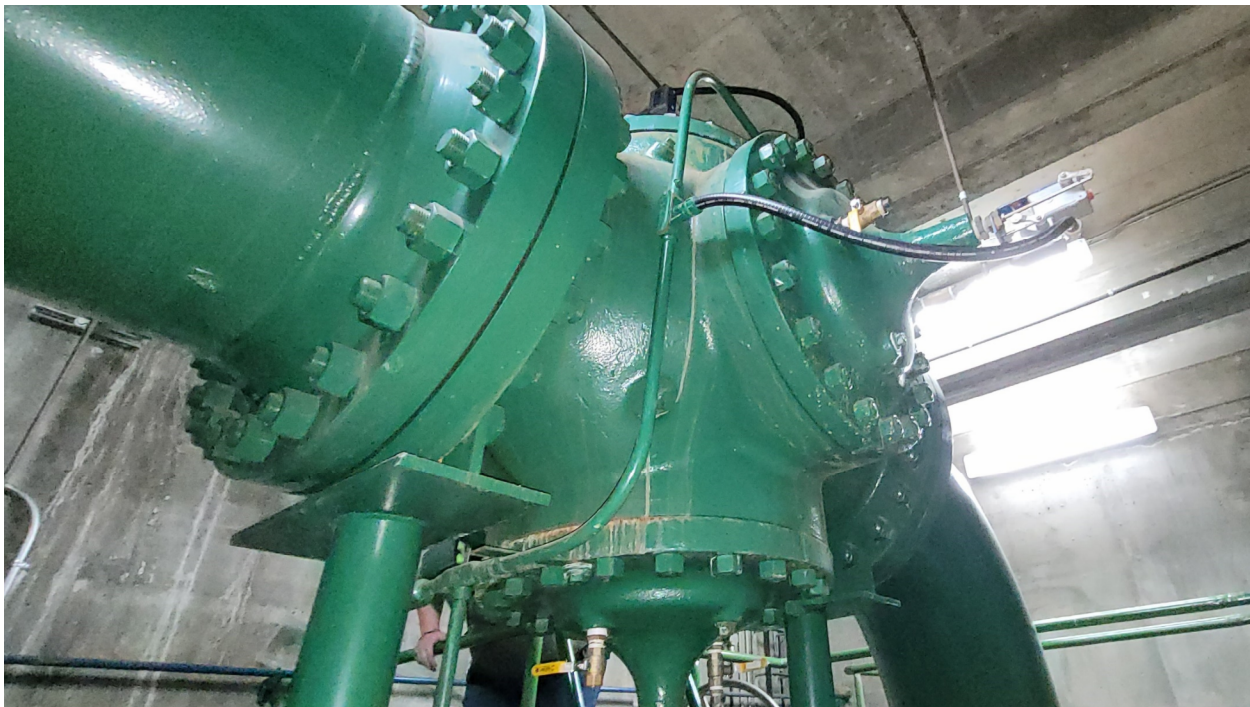
Figure 4.3 Vault 5 Hydraulic / Pressure Control Valve

- a. The original raw water magnetic flowmeter failed in 2005 and was replaced with a clamp on ultrasonic flowmeter which is at the end of its service life and discontinued, resulting in no spare parts being available. A new magnetic flowmeter should be installed within the next five (5) years. (Medium)

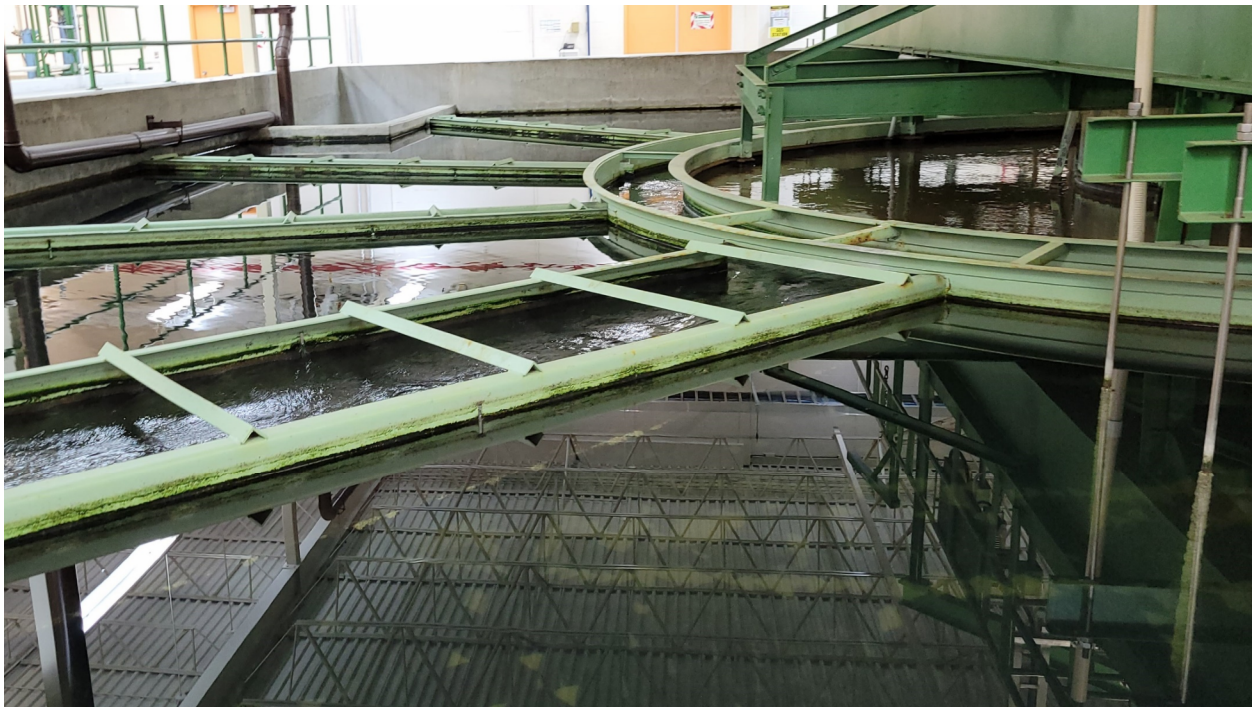
Figure 4.4 Solids Contact Clarifier

- d. Two sludge pumps are used to withdraw the settled sludge from the bottom of the clarifier and discharge it to the sanitary sewer. Both pumps. (P-123 and P-124) are showing no indications of any issues, but both are beyond their service life. As such the pump / motor should be replaced within the next five (5) years. (Medium)

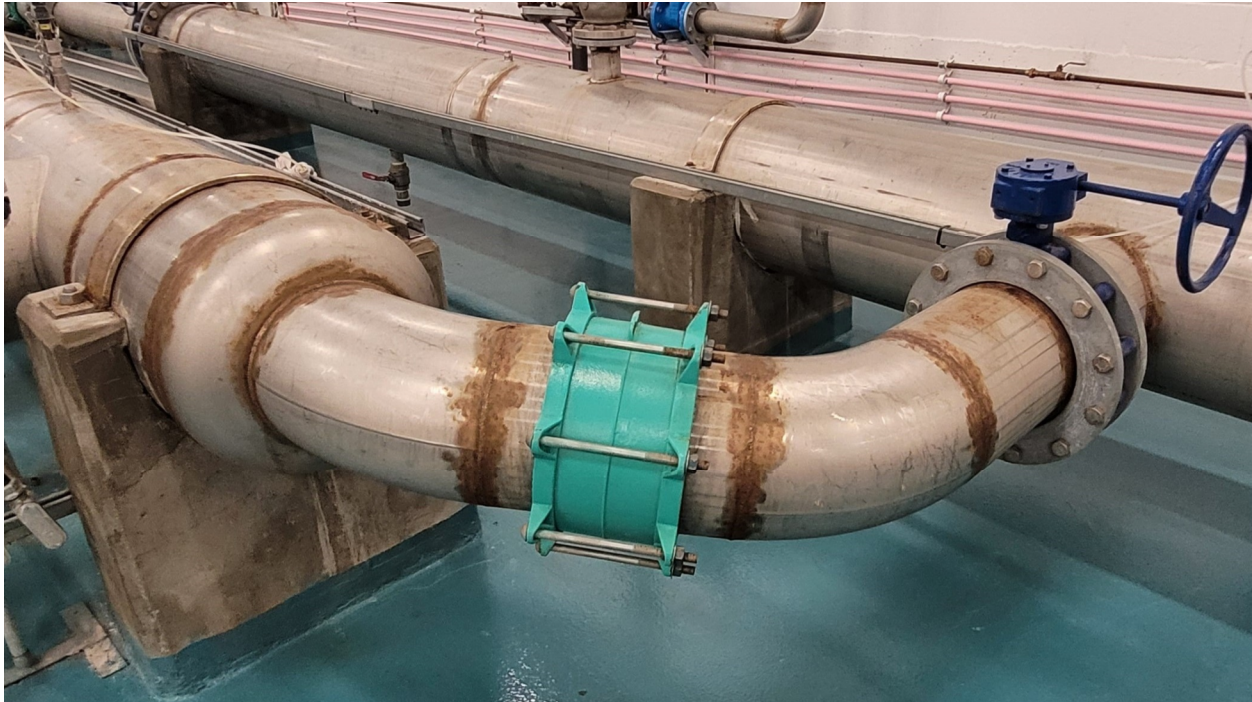
Figure 4.5 Corroded Pipework Welds

- b. Once ventilation issues addressed, clean, prepare, pickle and passivate all external areas of corrosion (inc. welds). ISL recommend that an initial test is completed within the next five (5) years and if successful a program is set up to complete a specific area per year until complete. (Low)

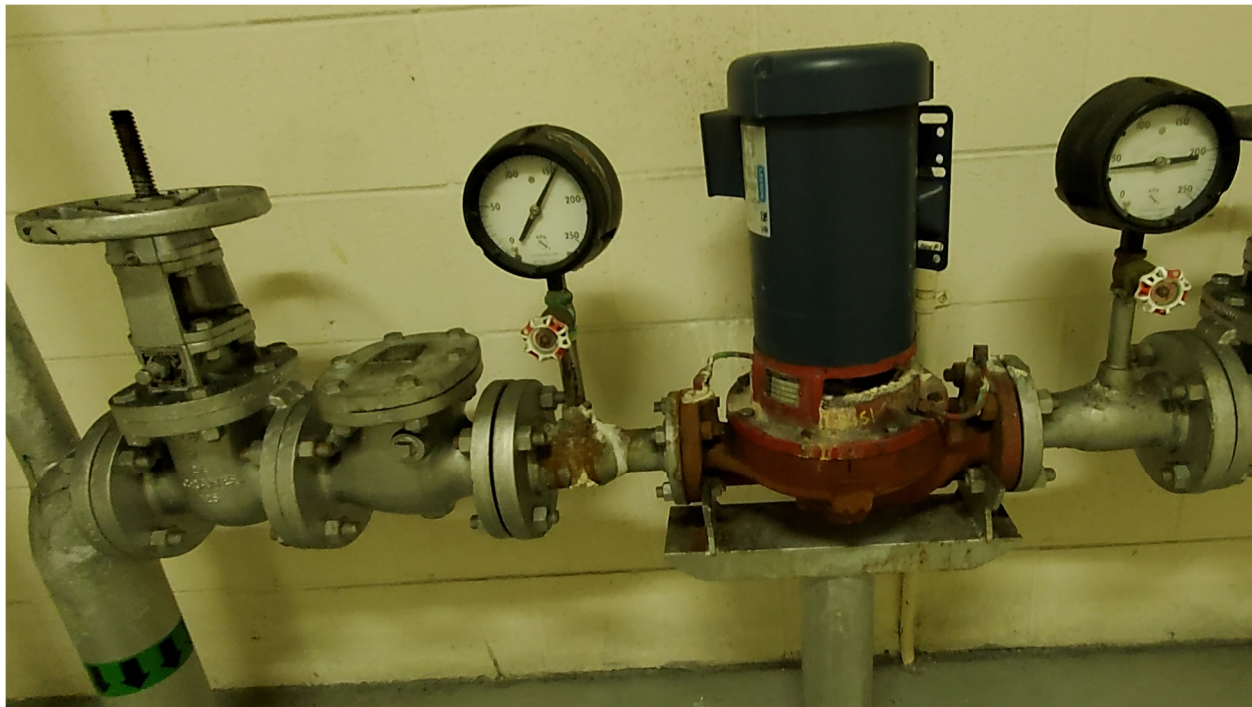
Figure 4.6 Glycol Pump P-210

- d. Temperature control valve TCV-35 is showing signs of leakage and is nearing the end of its service life. It should be replaced in the next five (5) years. (High)

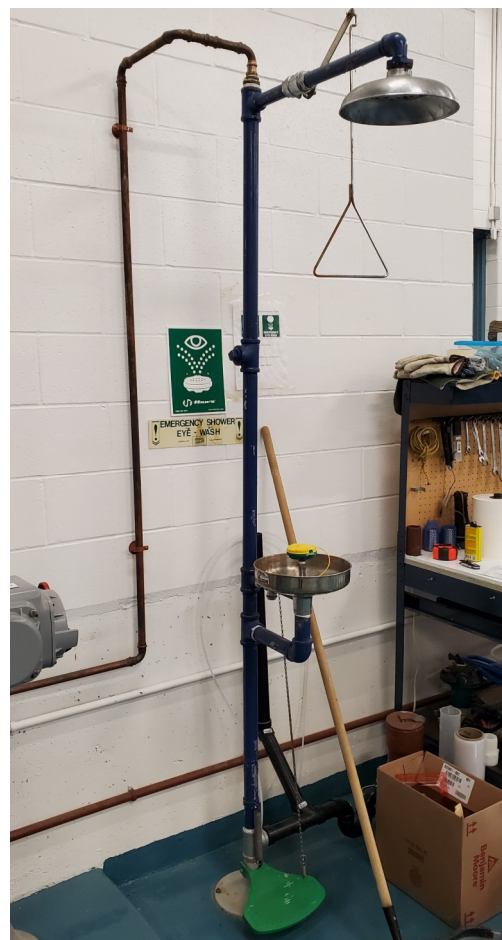
Figure 4.7 Safety Shower and Eye Wash Station

1. Unit heaters UH-1 and UH-2 appear to be in good working order but are nearing the end of their service lives. These unit heaters should be replaced with new equipment within the next five (5) years. (Low)
2. Furnace FUR-1 appears to be in good working order but is nearing the end of its service life. The furnace should be replaced with a new unit within the next five (5) years. (Low)
3. Eye wash station and shower EW-1 is not supplied with tempered water, which is a requirement of the ANSI Standard Z358.1. Non tempered water can cause a worker using this station to become hypothermic or to not rinse/wash for a long enough time. As soon as possible a tempering valve and hot water supply with sufficient volume to meet the required flow of tempered water should be added. (High)

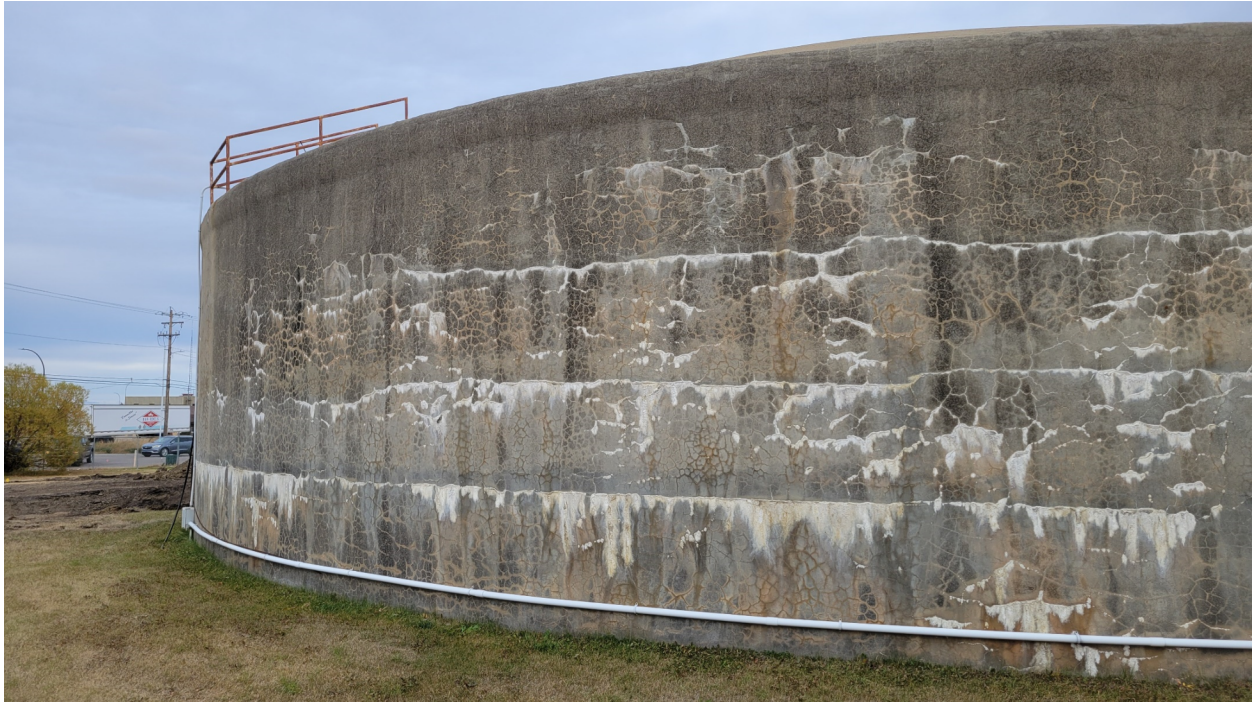
Figure 4.8 Circular Reservoir at the West End Reservoir

6. The masonry wall alongside the access road is in poor condition with numerous blocks toppled. The wall should be rebuilt to specifications and coordinated with new access stairs / ramp within the next five (5) to ten (10) years. (Medium)
7. The West End Reservoir includes a circular concrete reservoir which was constructed in 1974. A previous assessment in 2010 stated the reservoir was in a poor to fair condition at that time. The reservoir is now beyond the high end of a typical service life range. (i.e. 50 years) and in conjunction with its current condition, the City should plan for its removal from service and demolition in the next five (5) to ten (10) years. (High)

- Decommission and demolish the circular reservoir within the next five (5) to ten (10) years.
- Complete a structural inspection of the interior of the reservoir cells around 2031, when the reservoir has been in service for 25 years.
- Plan to expand the potable water storage capacity within the water distribution system as per the City of Lloydminster Water Master Plan (ISL 2024). Adjustments may be required based upon the demolition of the circular reservoir.

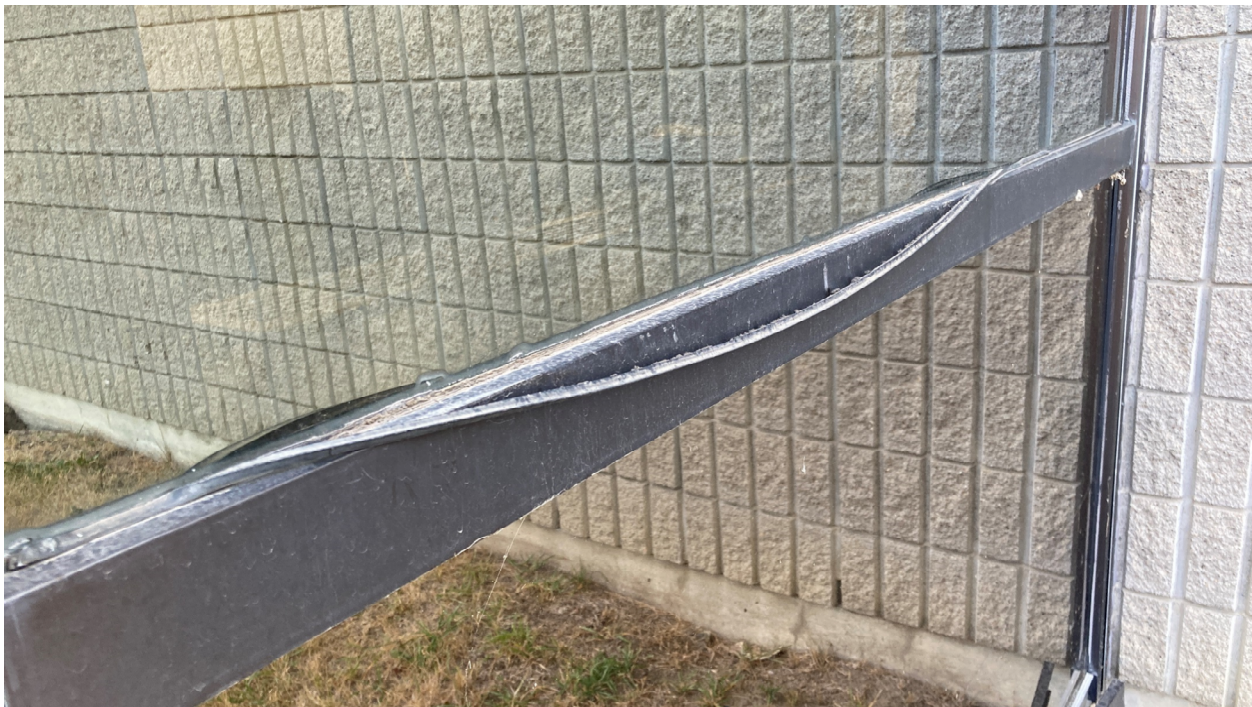
6. The curtain wall around the front entry area is in poor condition, with cracked and failed sealant, damage to beauty caps, openings at joints in the beauty caps, and deformed and broken beauty caps. No weep holes were observed in the beauty caps, and it is unclear how the system is drained. The curtain wall either needs to be refurbished or replaced. (preferred) within the next five (5) years. (High)

Figure 4.9 Curtain Wall Damage

- Investigate the condition of the WTP's roof within the next five (5) years, which will likely lead to the replacement of the WTP roof.
- Replace the curtain wall at the front entry area within the next five years (5).

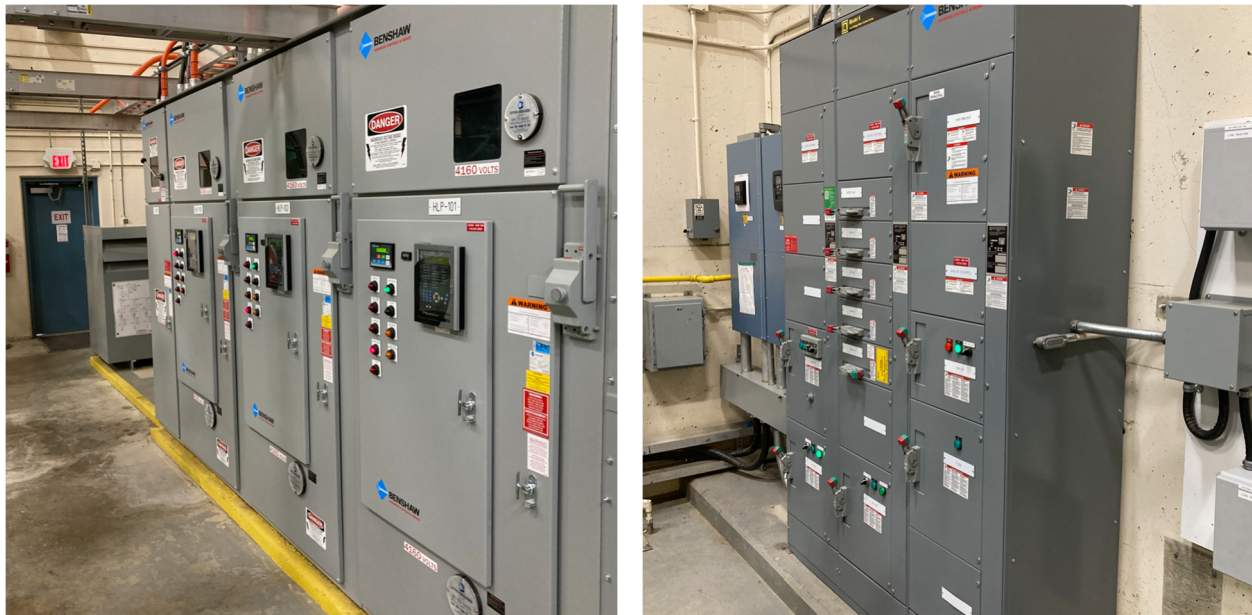
Figure 4.10 River Pumphouse 4160v Switchgear and 600v Motor Control Centre

1. There is no redundancy for critical pumping process. Electrical equipment is well maintained and in working order, but additional redundancy is recommended due to process impact if failure occurs. (Low) Note: this rating is reflective of electrical requirements but may be deemed higher urgency from a process perspective.
2. Equipment within the pumphouse is in good condition and well maintained. There are no immediate requirements for electrical equipment replacements due to age or end-of-life.
3. General building services are in good condition, however there is no fire panel or annunciation equipment located within this building. This is allowed by code given the building classification; however it could be a future upgrade consideration. (Low)

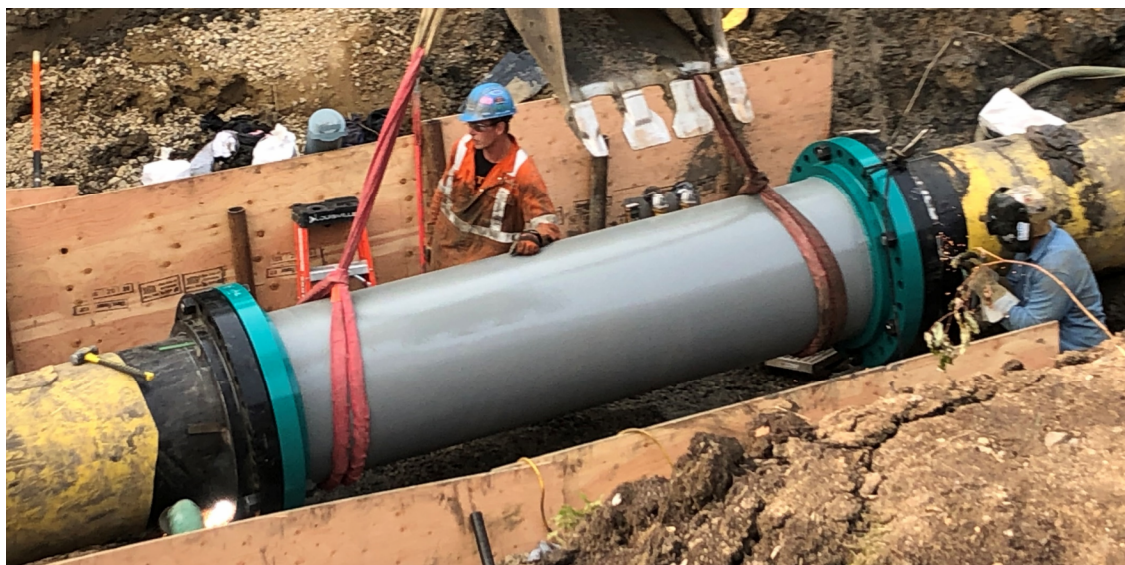
Figure 5.7 Raw Water Pipeline Repair 2020

It is also important to note that the raw water reservoir provides a secondary function, it terms of mitigating spikes in the raw water quality (primarily solids), thus reducing dramatic changes at the inlet to the WTP which subsequently required adjustment to the treatment process.
